FACTS AND FINDINGS FROM THE ACCIDENT

Charting Aspects of the Â-Volvo Ocean Race Stranding

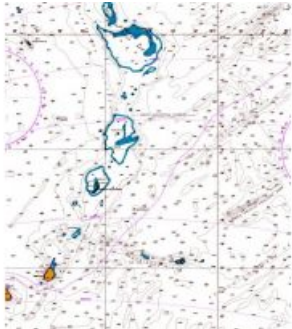
- The shoals are also clearly indicated as a drying feature on two small-scale (planning and overview) paper charts. BA4072, covers the whole of Leg 2. BA4702 (Figure 1) includes the critical section of the shoals northward from Mauritius and covers the Chagos Archipelago to the east.

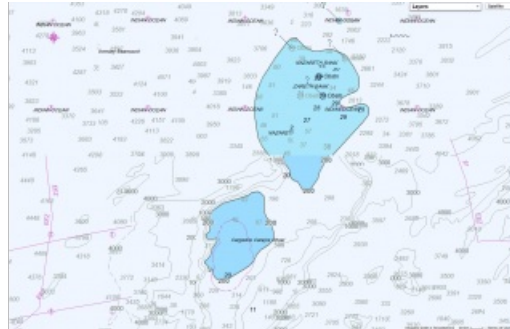
- The reef only shows up on the higher zoom levels of the chart plotter, and so if they had not zoomed in they would not have seen it (race navigation systems do not have the comprehensive route checking capabilities found in an ECDIS).

- At the zoom level interrogated by the navigator, the Cargados Carajos Shoals (Figure 2) are named and indicated by a blue shaded area bounded by the 200m isobath with spot depths from 20 to 82m. The navigator stated that the planned track passing over the shoal area was based on the least depth being 40m.
