LESSONS LEARNT FROM THE GROUNDING OF M/V STAR OPAL

Upholding SOLAS Responsibilities

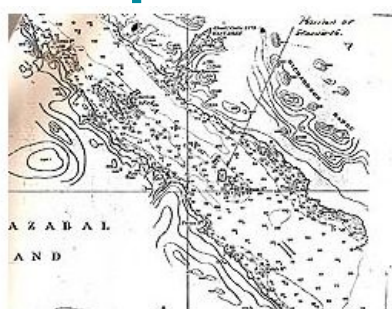
Aristazabal Island and Laredo Sound, in Canadian waters (Figure 1), were originally surveyed between 1922 and 1925 but not charted until 1941 (Figure 2). Large ships had been carrying bauxite ore to the port of Kitimat through this channel from 1954, for the purpose of smelting aluminium. The existence of the shoal in question was determined in June 1979, 55 years after the original survey. Many ships had miraculously passed over or around this shoal safely for 25 years. However, in November 1979, 150 days after the discovery of the shoal, a 20,000-ton bulk carrier ran aground on it. If a grounding had occurred earlier, the Canadian Hydrographic Service could have been found negligent for not carrying out modern surveys in this area.

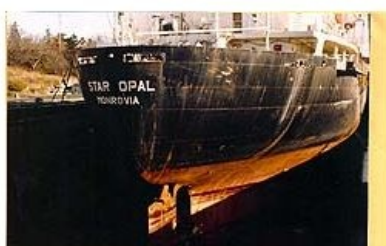
Upon hearing that the shipping company would probably bring a case against the Crown for the cost of the damage to their ship (Figure 4), a survey team returned to the site of the grounding on 18th November to investigate. It was found that the *Star Opal* had indeed hit the newly found shoal and left pieces of her bottom as well as paint on the shoal. The water was very clear and the divers took pictures of the grounding.
