MULTIBEAM SONAR FOR SHIP WRECKAGE LEAKAGE DETECTION

Norbit Winghead Wideband Multibeam Sonar Applied for Subsea Leakage Detection

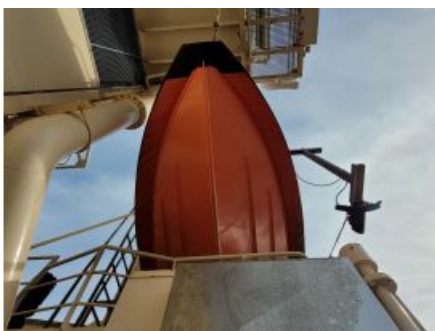
NORBIT integrated WINGHEAD i77h MBES mounted onto a small rescue-type craft in preparation for surface hydrographic survey work in Nootka Sound, west of Vancouver Island, Canada

The key objective was to make a rapid and accurate determination of the source of the diesel and oil that had appeared on the ocean's surface. The company carried out hydrographic survey work using a [Norbit Winghead i77h](#) multibeam echosounder (MBES) system. The team deployed the device both from the surface, mounted onto a

small rescue-type craft, and underwater, from a Helix remotely operated vessel (ROV) model XLX 66.

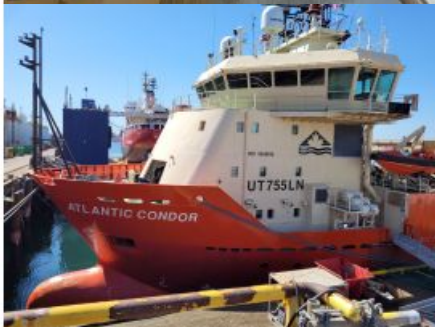
□ The ROV was tethered to the cargo ship and lowered into the water for the subsea survey work, which was performed at 10m above the seafloor.

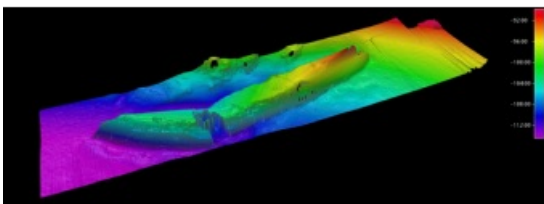
□ Bathymetry data results from the ROV survey (400kHz).

The bathymetric surveys showed the ship resting bottom-up on the seafloor. The multibeam images also revealed plumes of oil travelling through the water column. With these, responders were able to pinpoint specific areas of leakage from the hull that could not be captured by video surveys. Importantly, the images showed that the vessel was leaking from more than one area.
