# CREATING A 3D DATASET FROM A USV AND UAV SURVEY

## Cable inspections the uncrewed way

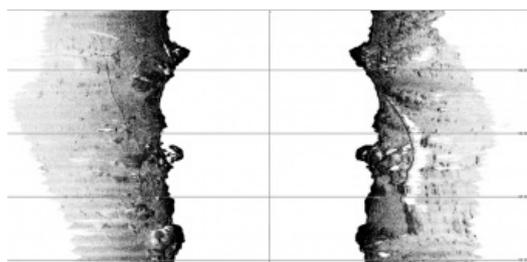
X-04 surveying near the Isle of Arran.
