HYDROGRAPHIC ACTIVITIES IN THE AFTERMATH OF THE EARTHQUAKE AND TSUNAMI DISASTER IN JAPAN

Hydrography After Huge Earthquakes

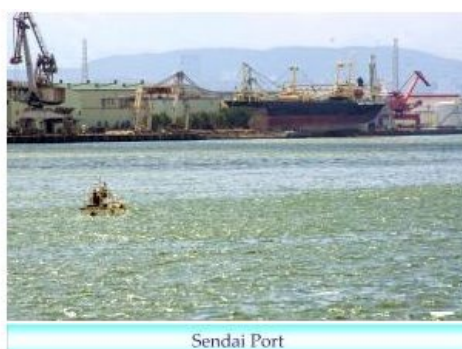
On 11 March 2011, a devastating earthquake (magnitude 9.0), by far the largest in recent Japanese history, hit the east coast of Japan (Figure 1). It was followed by an unprecedented huge tsunami, that had a maximum run-up height of 40m and spread wide (inundated area: 561 square km) and penetrated deep (6km from the shoreline). The tsunami surge was extremely powerful, completely destroying most of the facilities in the affected coastal area; jetties, ships,

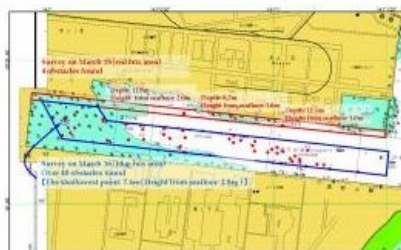
As a result of the tsunami surge, many ports and harbours in the east coast of Japan were significantly damaged: jetties and lighthouses were destroyed, objects submerged, debris, such as fishing nets, were set adrift, and there was variation of seabed topography due to erosion and sedimentation. In particular, sunken objects were a danger to vessels and needed to be removed. A prompt hydrographic

survey was vital in helping mariners guide their vessels into the ports (Figure 2).

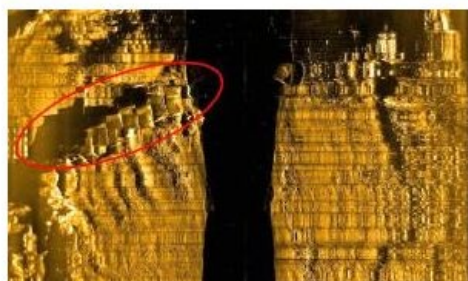
At this stage, both side-scan and interferometric sonar devices were useful tools for determining potential dangers (Figure 3). Single-beam and multi-beam echo sounders were also used to measure the depth of the highest point of obstacles. Lists of the dangers in surveyed areas were drawn up every evening (Figure 4) and reported to the port authorities. The port authorities could then remove obstructive objects depending on the risk (Figure 5).
