# USING MULTIBEAM BATHYMETRY, TOPOGRAPHIC LASER SCANNING & UAS PHOTOGRAMMETRY

## Marine Asset Integrity Mapping

Marine GeoSolutions have extensive experience in acquiring combined multibeam bathymetry & topographic laser scanning datasets and partnered with Land Surveys to demonstrate the viability of this technology over a test area along the Hillarys Boat Harbour breakwater in Perth, Western Australia.

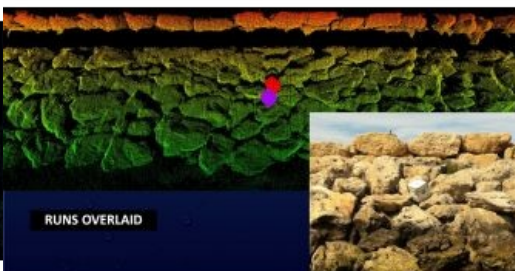
In order to test the accuracy & repeatability of the topographic laser scanning and the positioning system, two small objects were placed along the skyline of the Hillarys breakwater to investigate if these items could be mapped with the laser system. One of the items (a Crown beer bottle) was left stationary on the breakwater for two separate survey runs, and a second item (a Blackberry phone) was moved a small distance (0.070m) between the two survey runs. Comparisons of the skyline laser data between the two survey runs revealed an agreement of  $\pm 0.01\text{m}$  for the centre-point of the stationary Crown beer bottle position, while the two recorded positions of the Blackberry phone confirmed that the phone had been moved one phone width (0.075m) between the two survey runs; the actual phone width is 0.070m. The results of this test are shown in Figure 5.
