# A SEARCH AND RESCUE MISSION IN INDONESIA

## Key Role for Hydrography in Black Box Search Operation

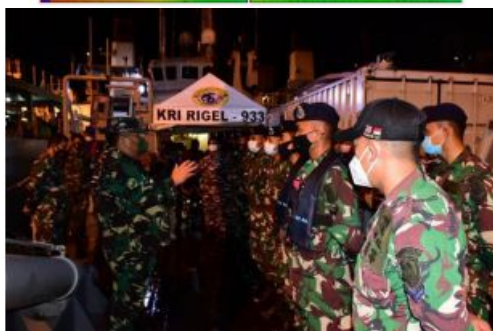
Figure 1: KRI Rigel-933.

a survey ship made by the French shipyard OCEA in 2015, with sophisticated hydrography and oceanography survey equipment.

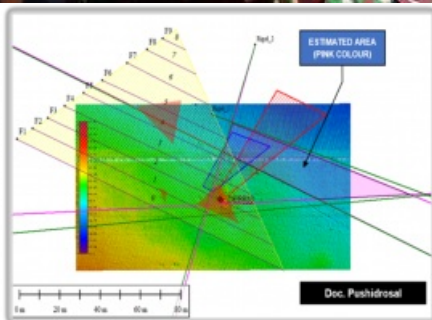
□ Figure 3: The result of the multibeam echosounder seafloor sweep.

The first step taken by KRI Rigel-933 at the search location was to search for debris using a multibeam echosounder (MBES). Sweeping suspected areas was successful in detecting seabed targets that were analysed as Flight 182 debris, and the position of the debris eventually became the main location of the SAR operations. The sea depth where the debris was found was around 14–20 metres, with a mud sand seabed. Underwater visibility at the location also allowed a black box search by divers. KRI Rigel-933 also conducted a magnetic anomaly survey using a magnetometer to determine the position of the debris distribution.

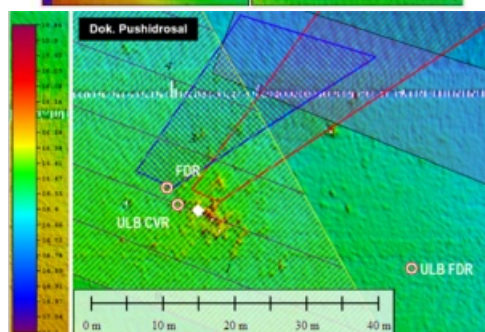
□ Figure 4: Triangulation method to determine the estimated position of the black box.

In this operation, a signal was detected by HiPAP, but the only information received in this way is distance information. Therefore, to obtain position data using the signal from the black box, the next step was to use the triangulation method to detect black box signals from at least three different positions. The intersection of the signals from the three or more data collection positions produced an area that was estimated to be the location of the black box. Although the position obtained by this triangulation method was not an accurate position, it narrowed the black box search area so that the search operation could focus on that area. The search for the black box was then continued using divers in the position that was obtained.
