Monitoring Coastal Changes in Greece

Hundreds of satellite images spanning over 25 years have been compiled to show the evolution of Greece's ever-changing coastlines.

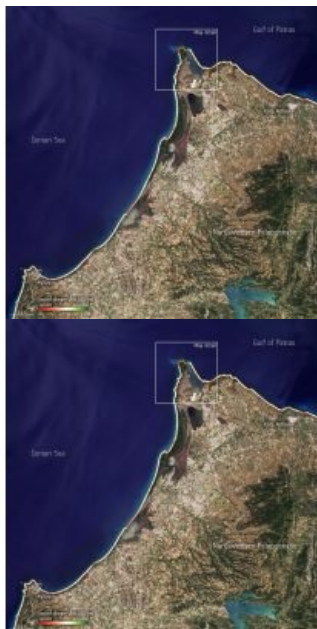
Coastlines in Greece mapped by Space for Shore.

Two key players of the consortium, [Terraspatium](#) and [i-Sea](#), have processed hundreds of satellite images, including data from the [Copernicus Sentinel-2 mission](#), from 1995 to 2020 to analyse over 900km of coast in Greece – in the Peloponnese, Eastern Macedonia and Thrace regions.

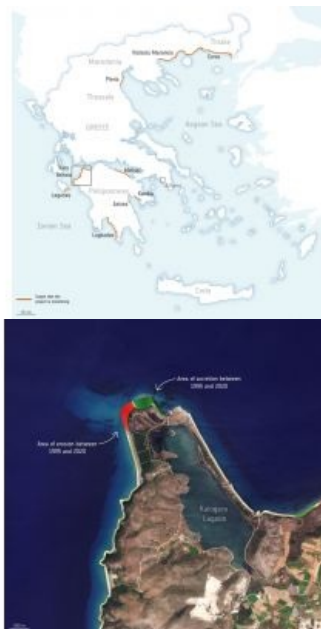
Peloponnese coastline changes.

The results highlight the fragility of Greece's coastline and indicate the likelihood of coastal erosion increasing in the coming years. Over the 1995–2020 period, around 40% of the coastlines analysed showed 'progradation', which is the seaward growth of beaches caused by the progressive build-up of sediment. The team found that nearly 10% of the studied coastal areas are subject to erosion greater than 3m per year.

Deltas, estuaries and capes appear to be the most exposed areas with retreat that can reach 30m per year. Erosion at river mouths is especially of great concern as this signifies a sediment deficit and suggests critical and long-lasting consequences for coasts deprived of sediment input from rivers.
